# **Inventory of Current Conditions and Land Uses**

## **Red Rock Road, Douglas County**

**Oregon Department of Environmental Quality  
and  
The Weyerhaeuser Company**

**June 2008**

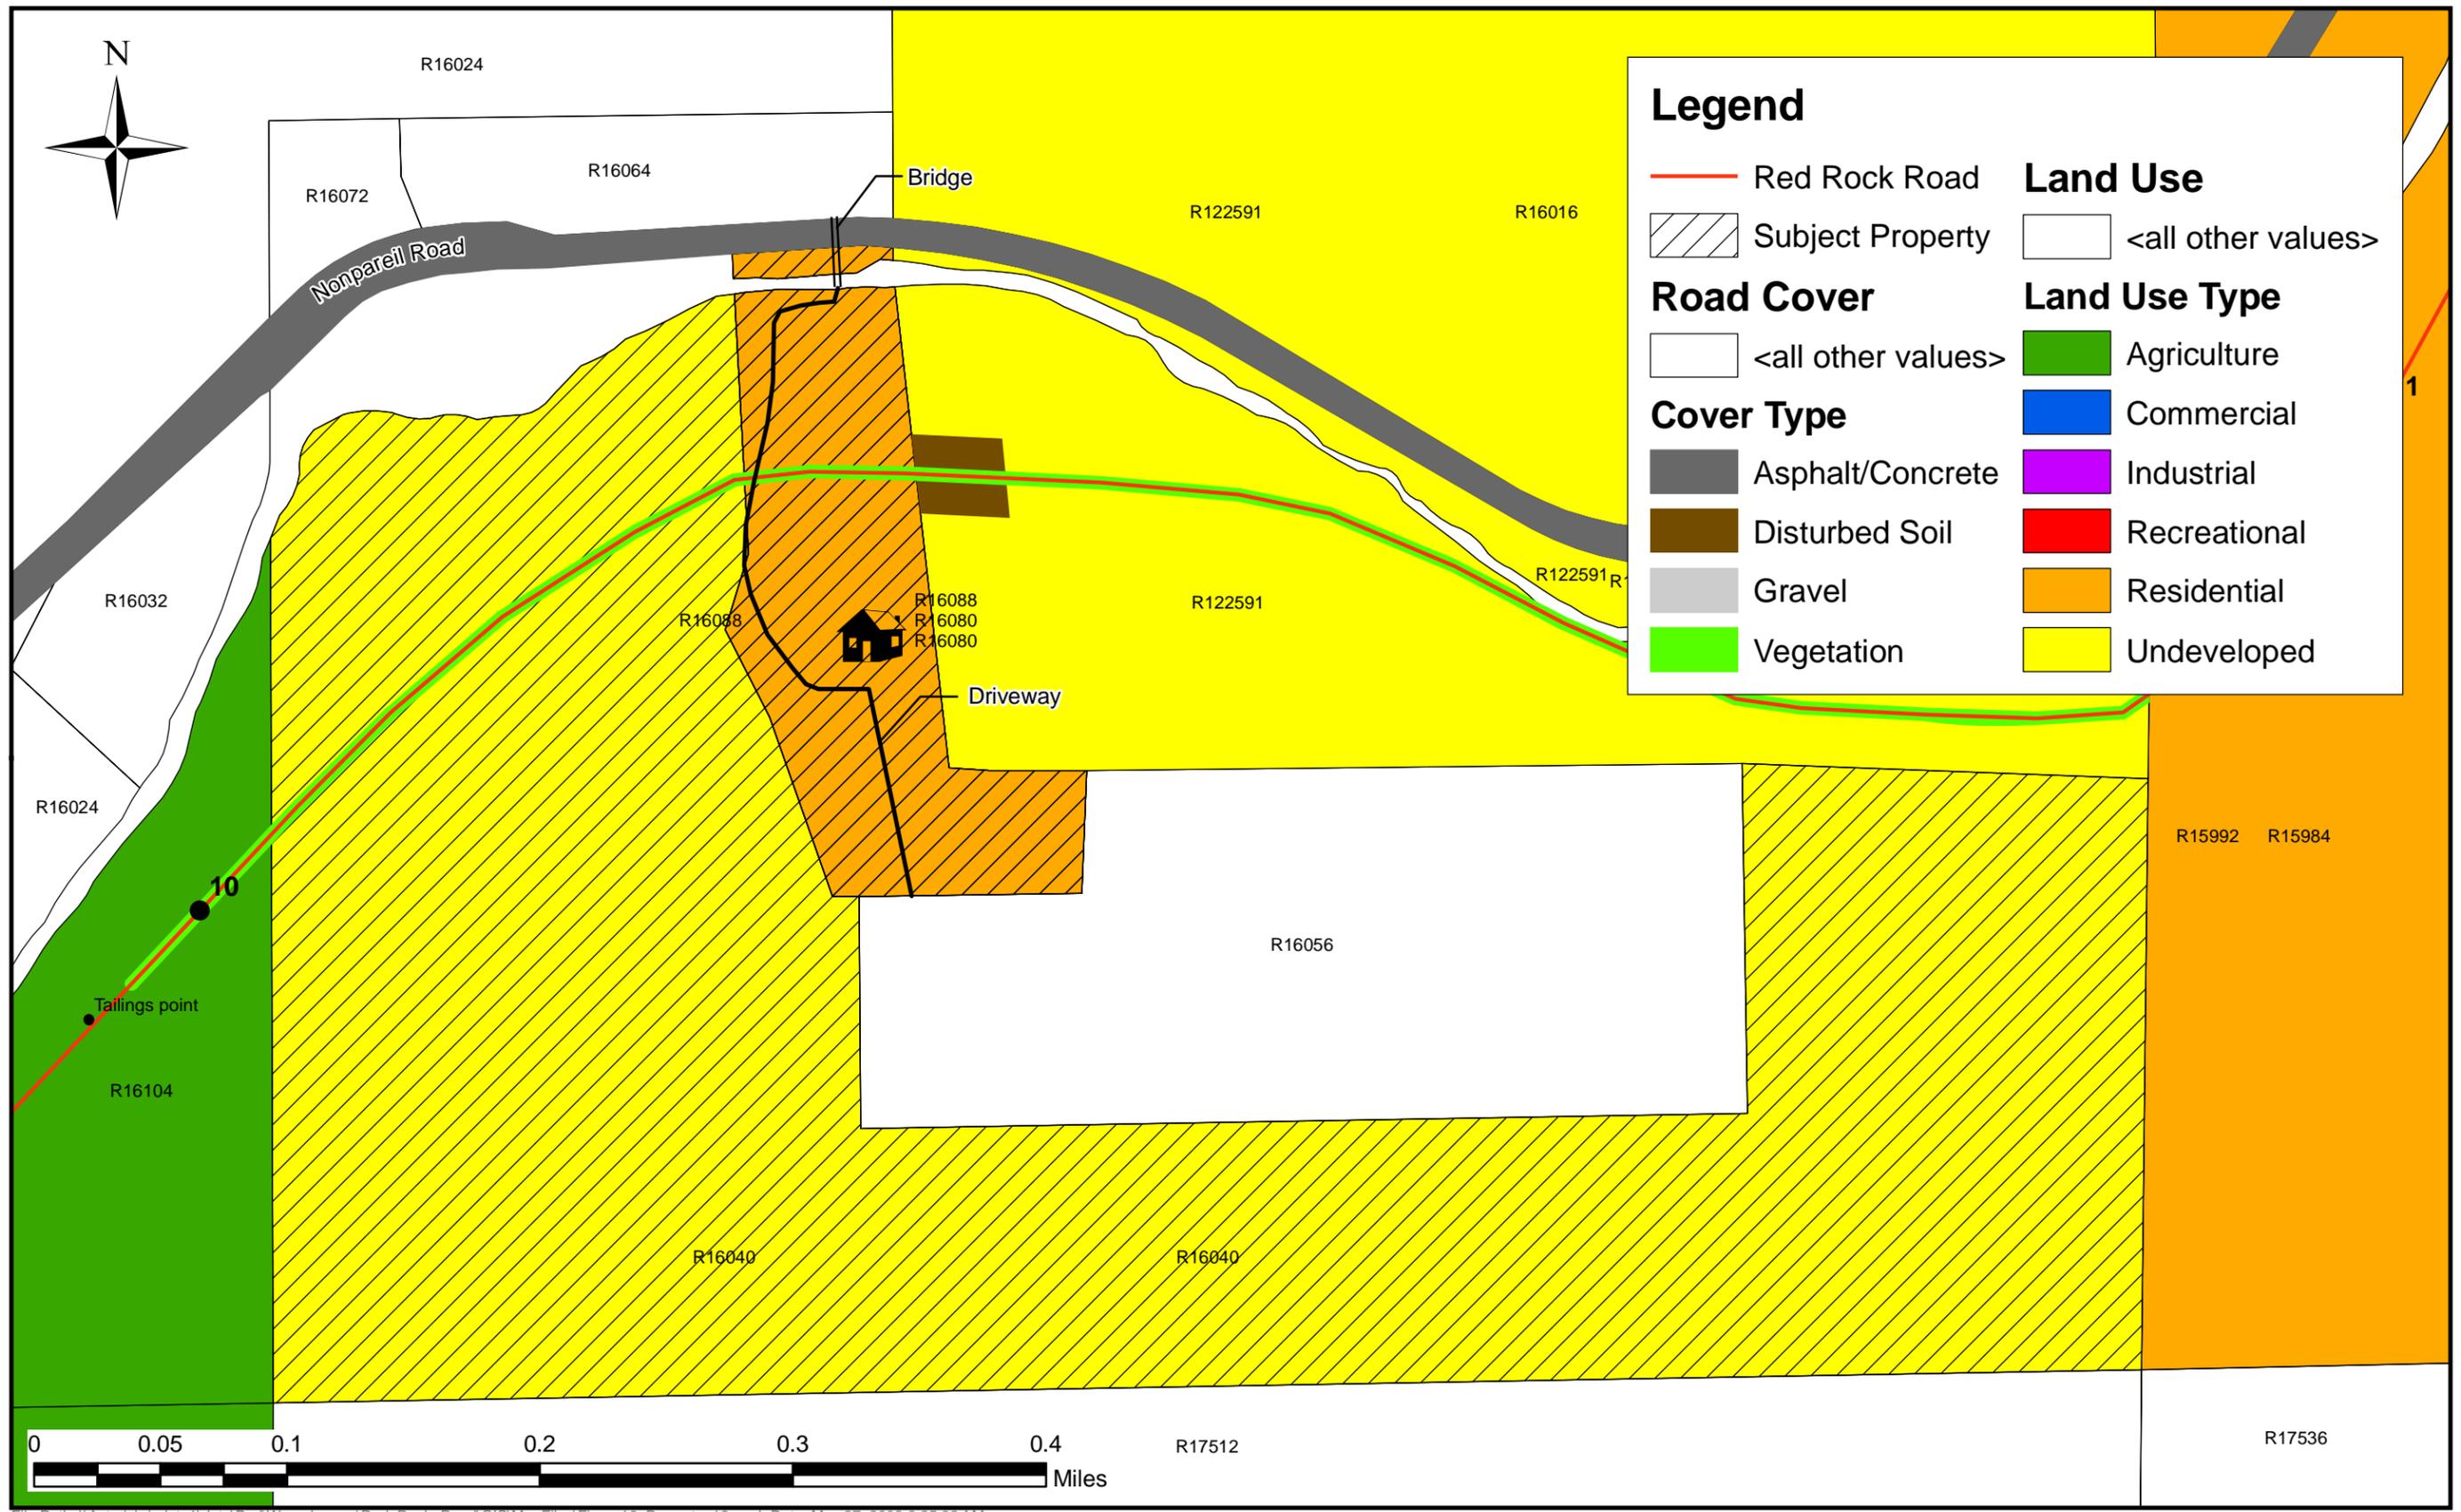
Figure 16  
 Map of Property #12  
 Parcel R16040, R16080 and R16088

These three parcels, located at approximately mile 10, comprise a 114-acre, gated, rural residential property. Red Rock Road crosses the parcels at the base of a steep hill, separating the home site near the top of the hill from the meadow below. The home site is located approximately 300 feet from RRR. Red Rock Road is crossed by the main driveway but is not used as the main access road. Vehicle traffic on RRR is limited to occasional access to fields for mowing and property maintenance. An area of disturbed soil showing use and exposing red soils were observed at the eastern property boundary (immediately adjacent to Property #11, above).
